PVP2010-25839

**TRI-AXIAL SHAKE TABLE TEST ON THE THINNED WALL PIPING MODEL AND
DAMAGE DETECTION BEFORE FAILURE**

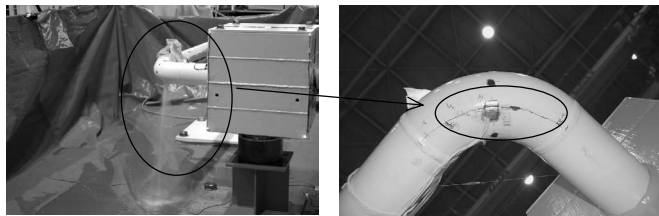
(a) AP3-A31 (at Elbow 3)

Fig.5 Failure modes of test models

Because the failure did not occur on both test models by the excitation of 750% Suttsu HPF, the excitations by a sinusoidal wave were conducted. The failure mode of AP3_A31 was the fatigue failure at the flank of Elbow3 which was subjected to in-plane bending. The failure mode of AP3_C31 was the fatigue failure at the neighbor of the weld at Elbow1 which was subjected to out-of-plane bending. Figure 5 shows the failure mode of these test models. The failure mode was the fatigue failure accompanied by the ratchet deformation, like as the failure mode obtained by the past research programs [1, 3]. The amount of the ratchet deformation was about less than 1% as for AP3_A31 and more than 8% as for AP3_C31.

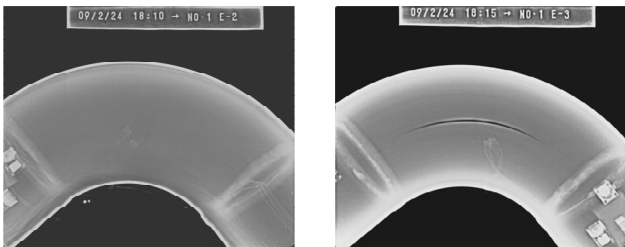
Fig.6 DRT result of AP3_A31

in the experiments, was finally caused from the defect in AP3_A31. Though the defect at Elbow3 after the whole excitations was detected by DRT, defects before failure were not detected by DRT. Figure 6 shows the result of DRT at Elbow2 and Elbow3 after all the excitations for AP3_A31.

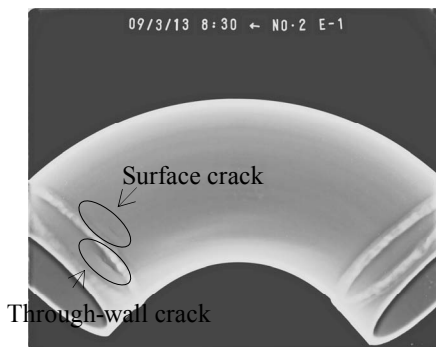
Fig.7 DRT result of AP3_C31, Elbow1

As for AP3_C31, defects were not detected by UT before the excitation. The defects were detected at Elbow5 after the excitation of 100% Suttsu HPF, at Elbow3 after the second excitation of 250% Suttsu HPF, at Elbow6 after the first excitation of 750% Suttsu HPF, and at Elbow2 after the third excitation of 750% Suttsu HPF. The defects at Elbow3 and Elbow5 detected in the middle of the excitation tests developed by following excitations. Though the failure was caused finally at Elbow1, defects were not detected at Elbow1 by UT. Though the crack was caused at the position where the sensor cables were obstacles to the inspection, it cannot be determined whether the defect at Elbow1 was not caused just before the failure, or the inspection was impossible due to the cables as a practical matter. A surface crack at Elbow1 on the other side of the pipe where the through-wall crack appeared was detected by DRT after the whole excitations, but other defects before failure were not detected by DRT. In AP3_C31, the maximum primary stress was estimated to occur at Tee as shown in Table 2. Though a remarkable ratchet deformation was observed at Tee, no defect was detected by UT or DRT in actual piping system model. Figure 7 shows the result of DRT at Elbow1 after the whole excitations for AP3_C31.
